Department of Water Resources

BULLETIN No. 183-2

# RIVERSIDE COUNTY FLOOD HAZARD INVESTIGATION— MURRIETA CREEK

MAY 1975

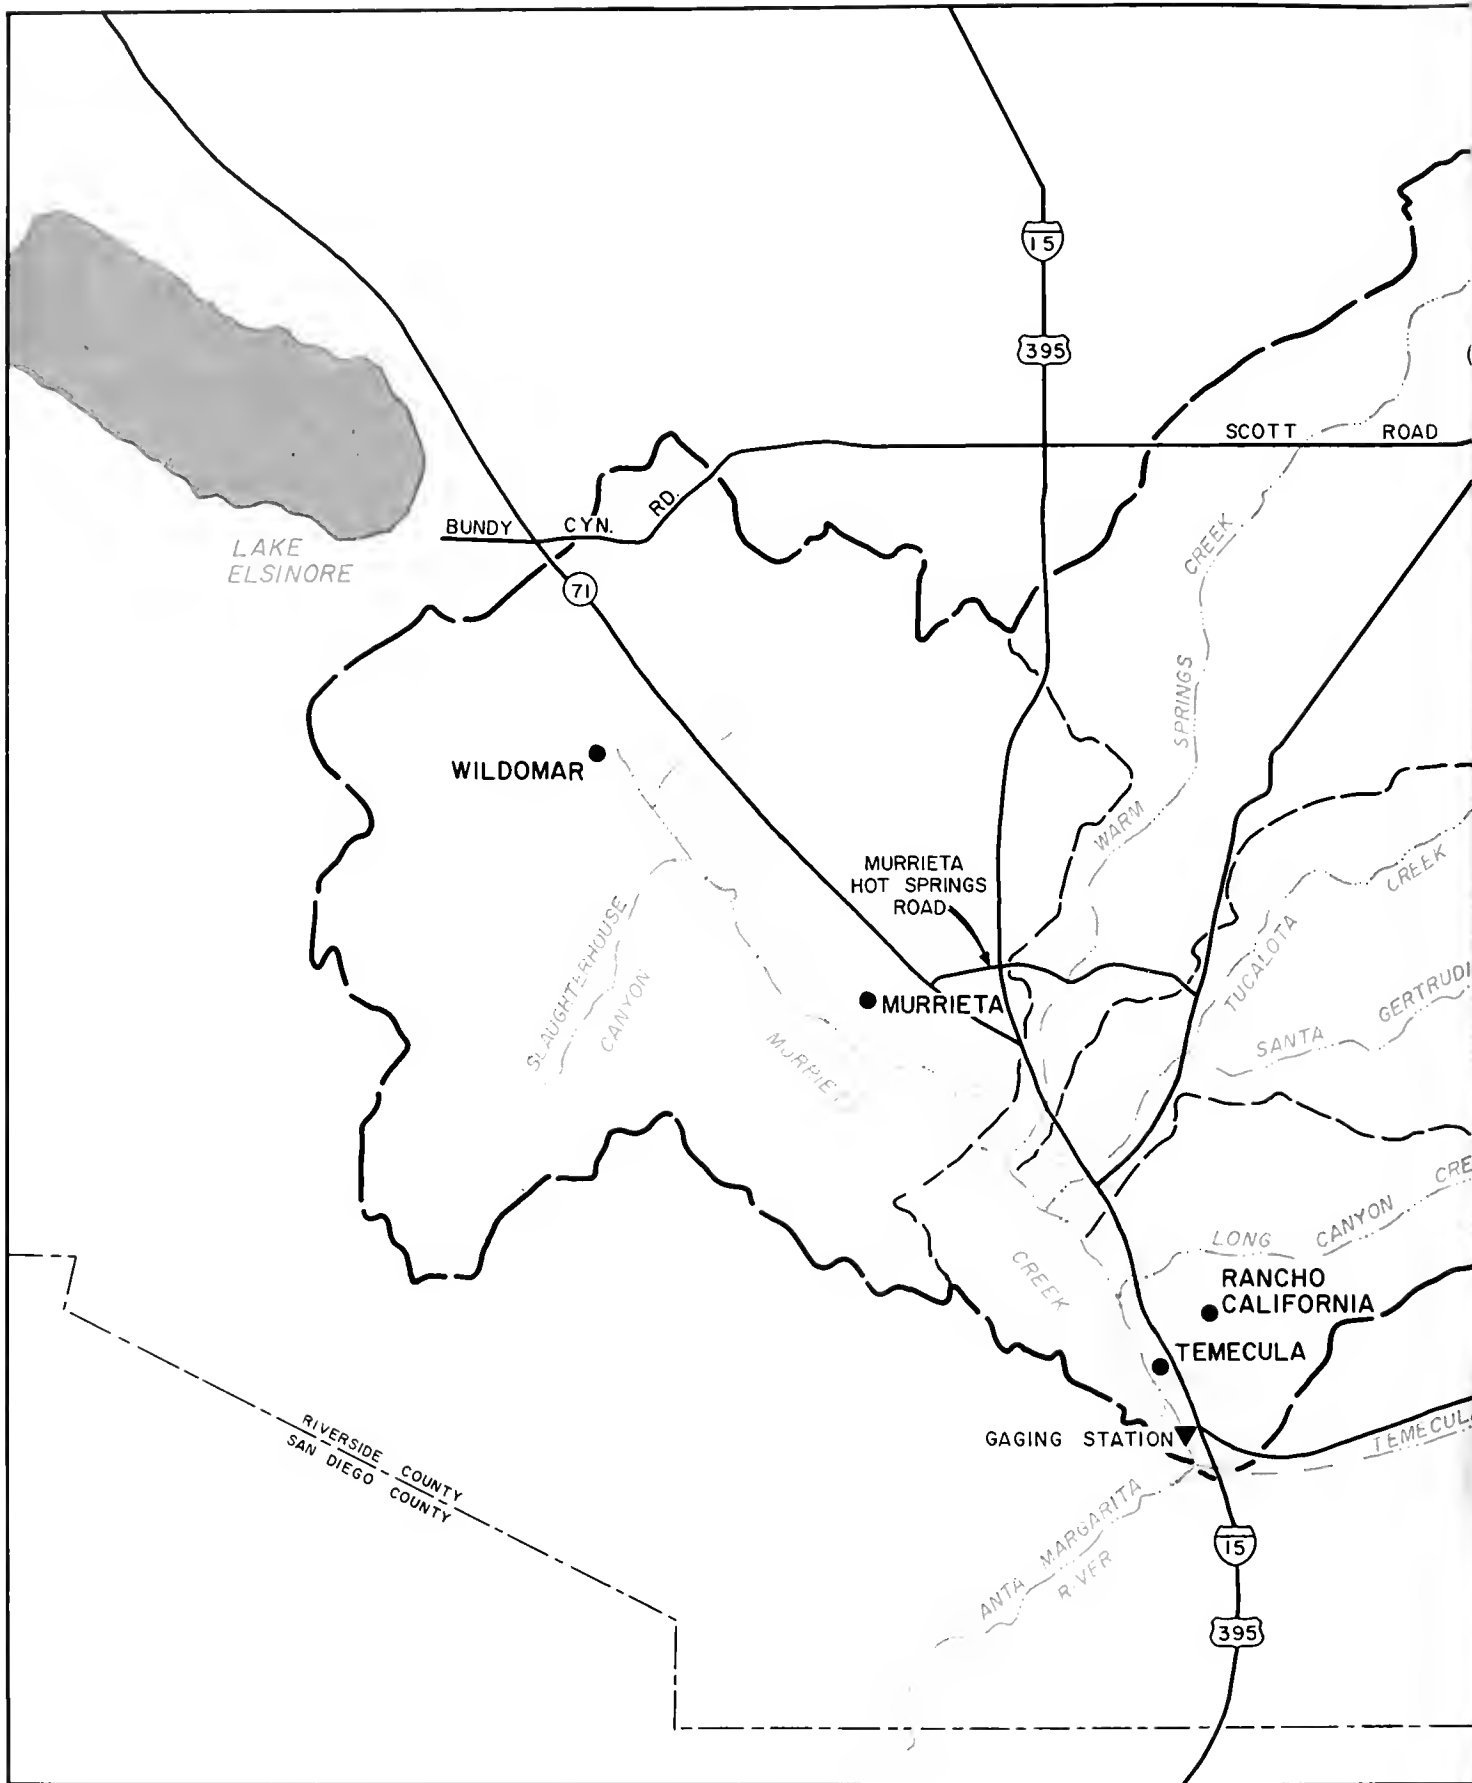
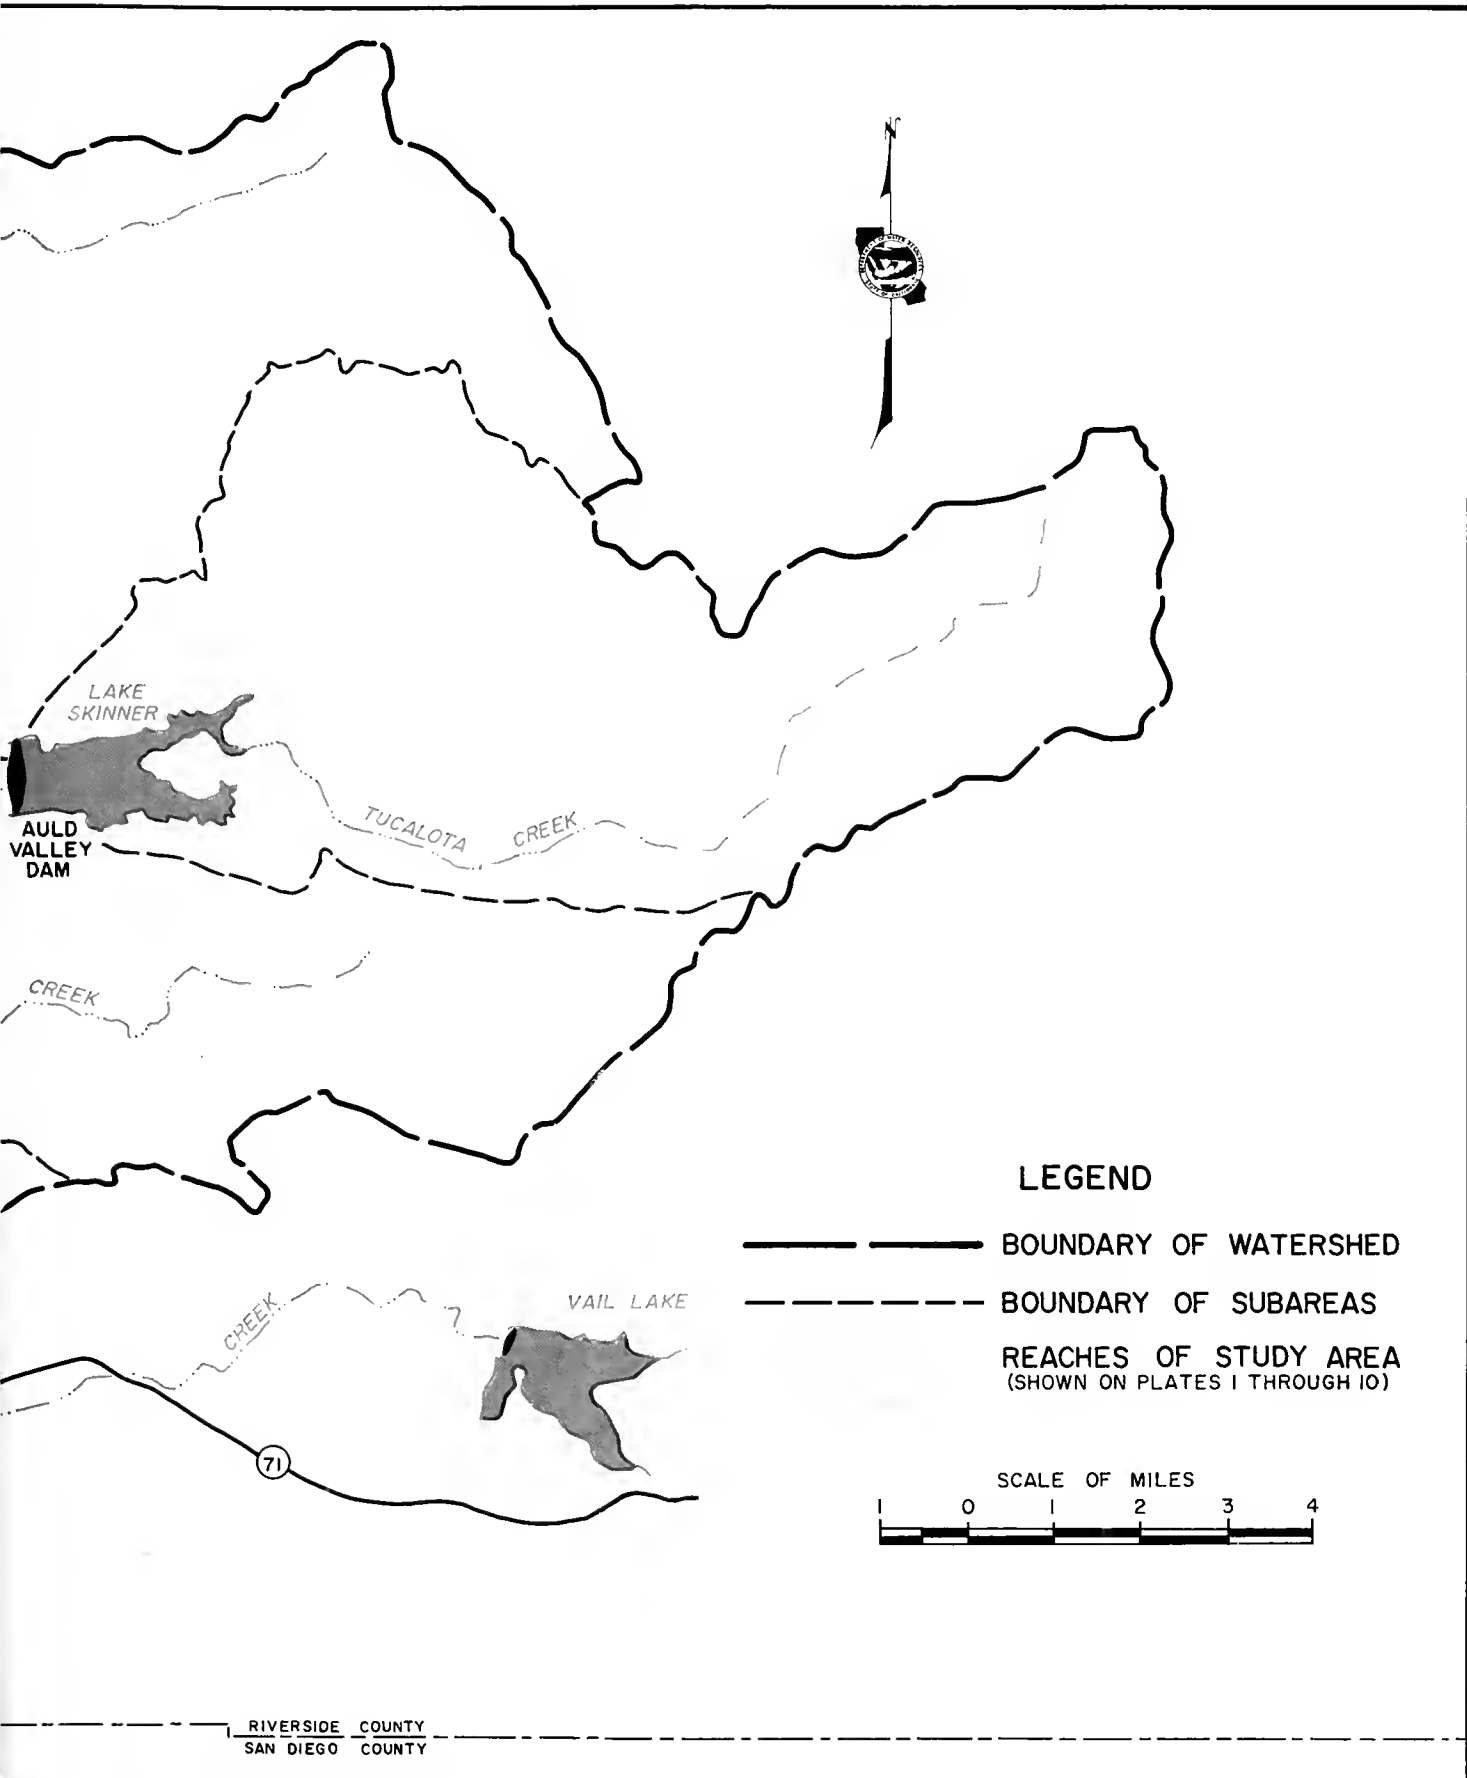
Figure 1—MURRIETA CREEK

The study area is in western Riverside County about 5 miles south of the City of Elsinore and consists of a portion of the Murrieta Creek watershed. (See Figures 1 and 2.) It covers Murrieta Creek southeastward from Slaughterhouse Canyon to its confluence with Santa Margarita River, a length of approximately 11 miles. It also includes the two major tributaries of Murrieta Creek, Santa Gertrudis Creek and Warm Springs Creek, from their confluence with Murrieta Creek to Escondido Freeway (Interstate 15).

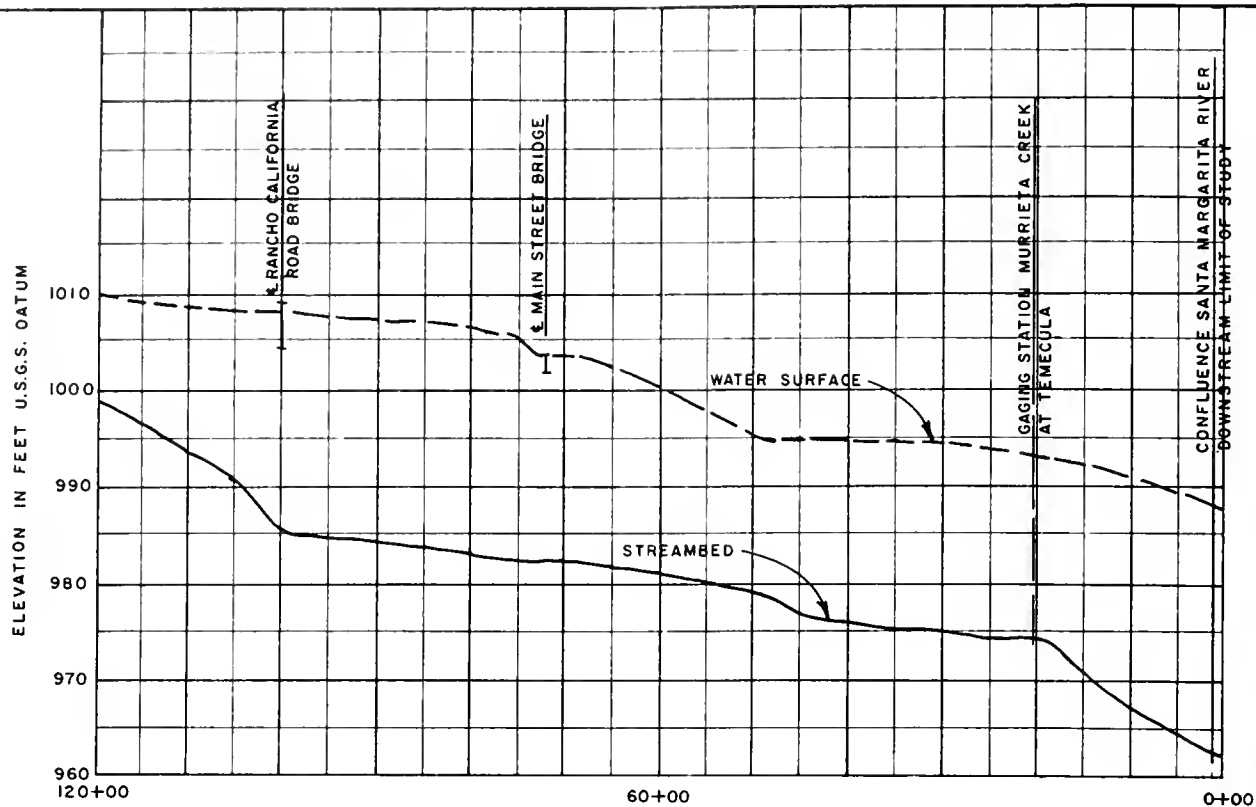
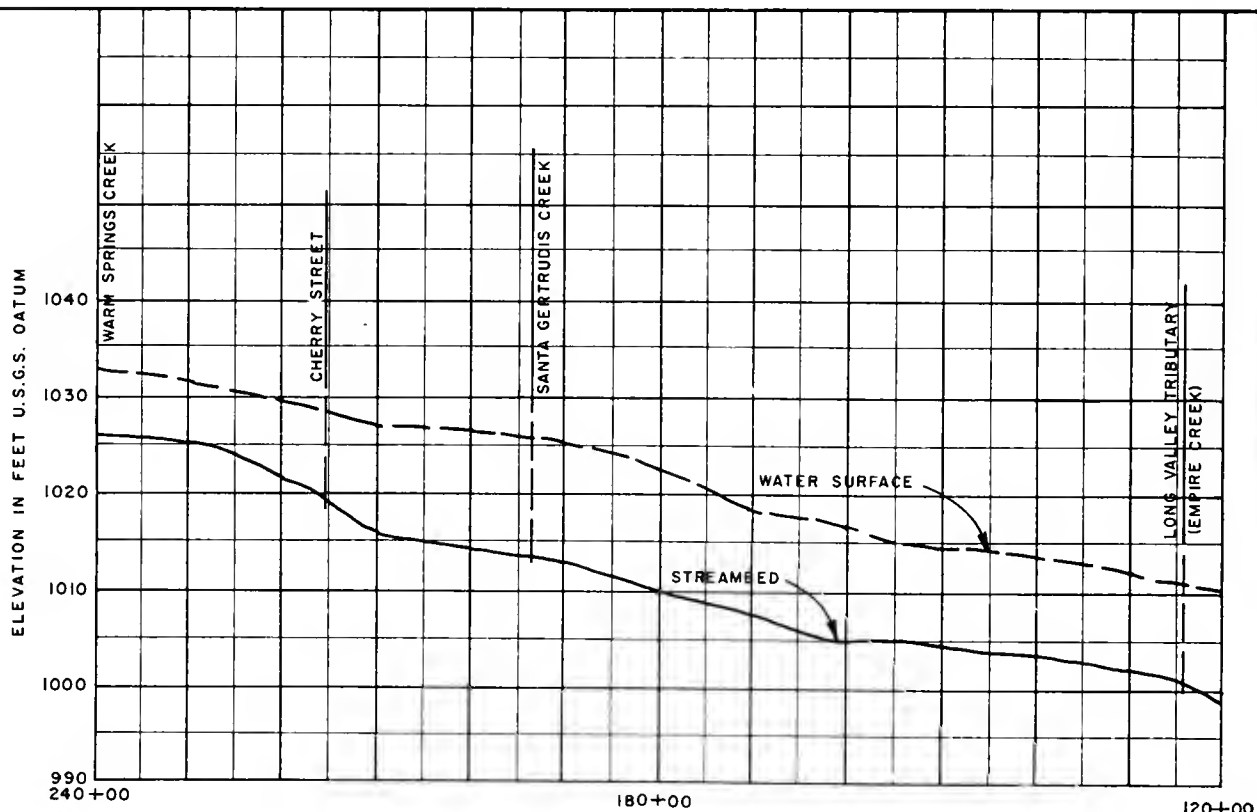
FIGURE 3-ESTIMATED 100-YEAR FLOOD PROFILE:  
MURRIETA CREEK (STATION 0+00 TO STATION 240+00)

The convergence was quite rapid and occurred well downstream of the study area. Figures 3 through 5 show the profiles of the streambed and the computed water surface elevations. The computations indicate that, for all practical purposes, the flow was subcritical throughout the reach. However, at points, the water surface elevations were below critical water surface elevations, indicating the possibility of a hydraulic jump. Further investigation showed that these jumps were of minor undulating nature. Computations were then continued upstream at these locations by assuming critical depth.

During high flow periods the velocity of the streamflow generally ranged from about 7 feet per second to 10 feet per second in the channel and from about 1 foot per second to 5 feet per second in the flooded areas. The depth of flow ranged from approximately 3 feet at the upper end of the study reach to over 20 feet near the downstream portion.

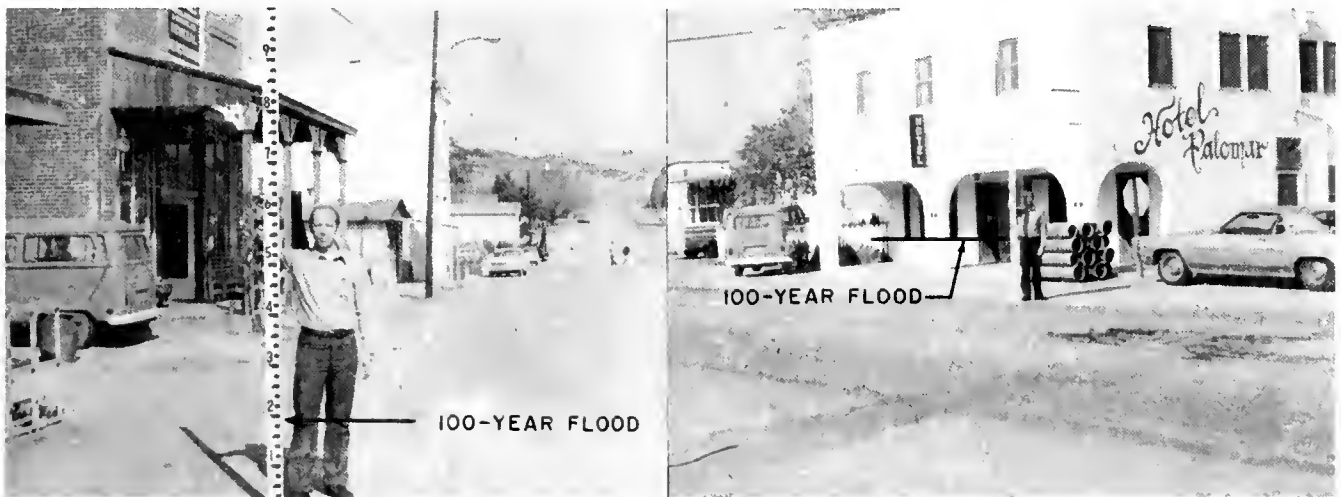
100-YEAR FLOOD HEIGHT IN TEMECULA. Left: On Main Street near Front Street. Right: On Front Street at Fifth Street

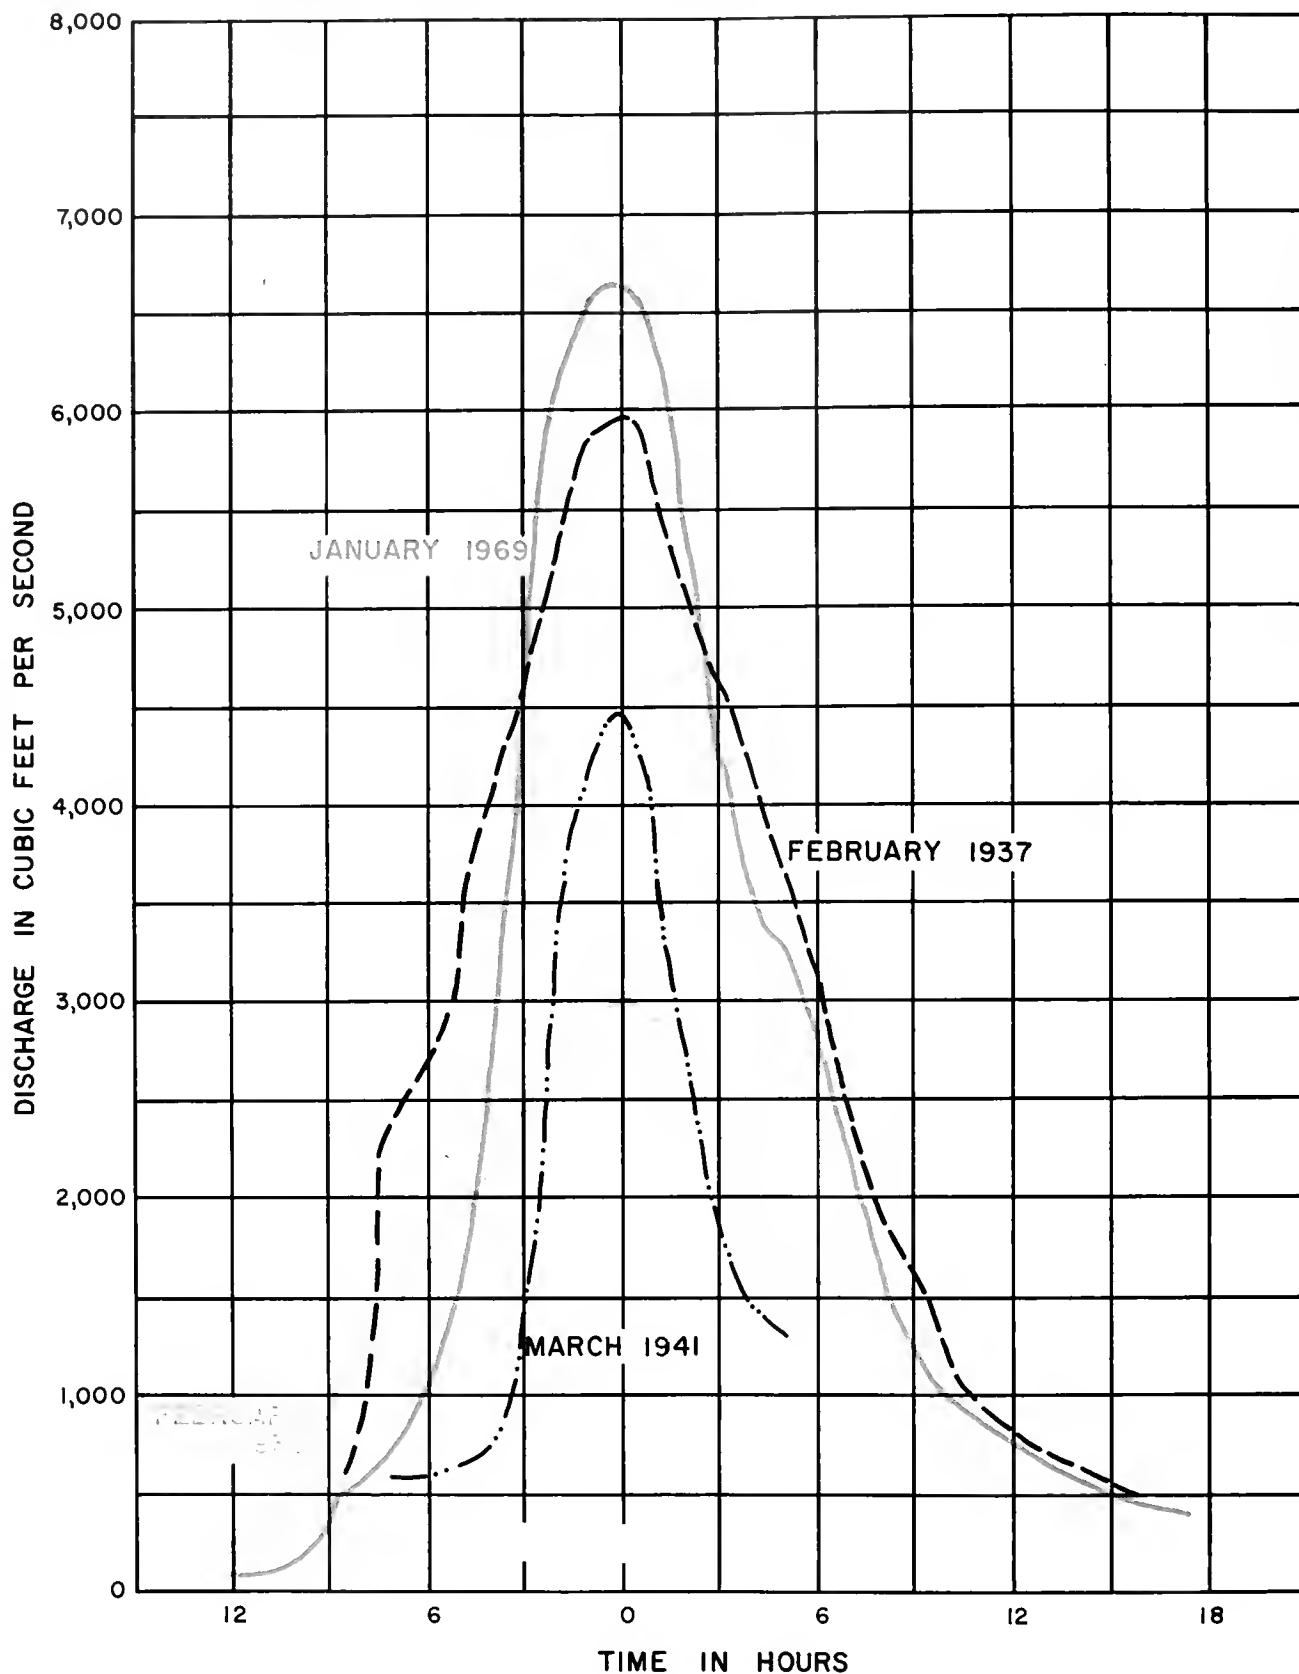
Figure 6—FLOOD HYDROGRAPHS OF RECORD,  
"MURRIETA CREEK AT TEMECULA"

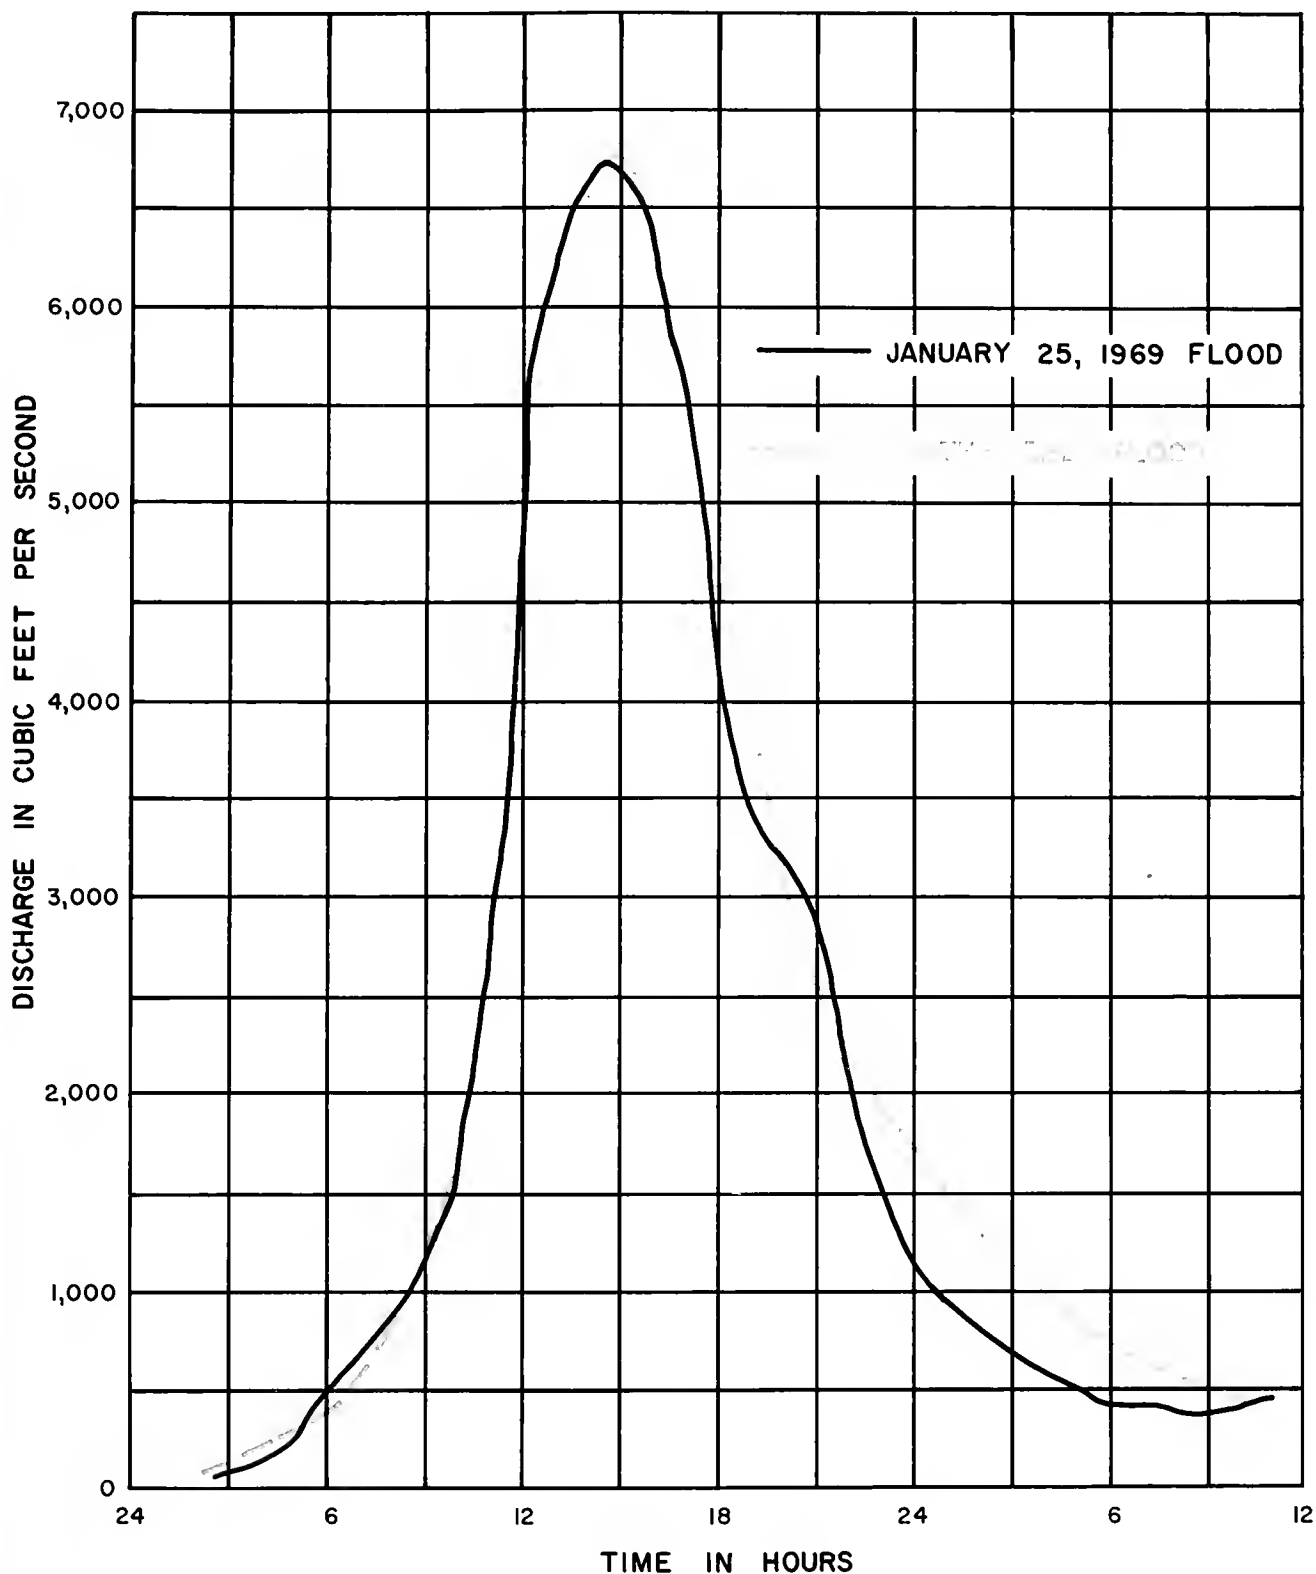
Figure 7— COMPARISON OF SYNTHETIC HYDROGRAPH  
WITH JANUARY 1969 FLOOD HYDROGRAPH

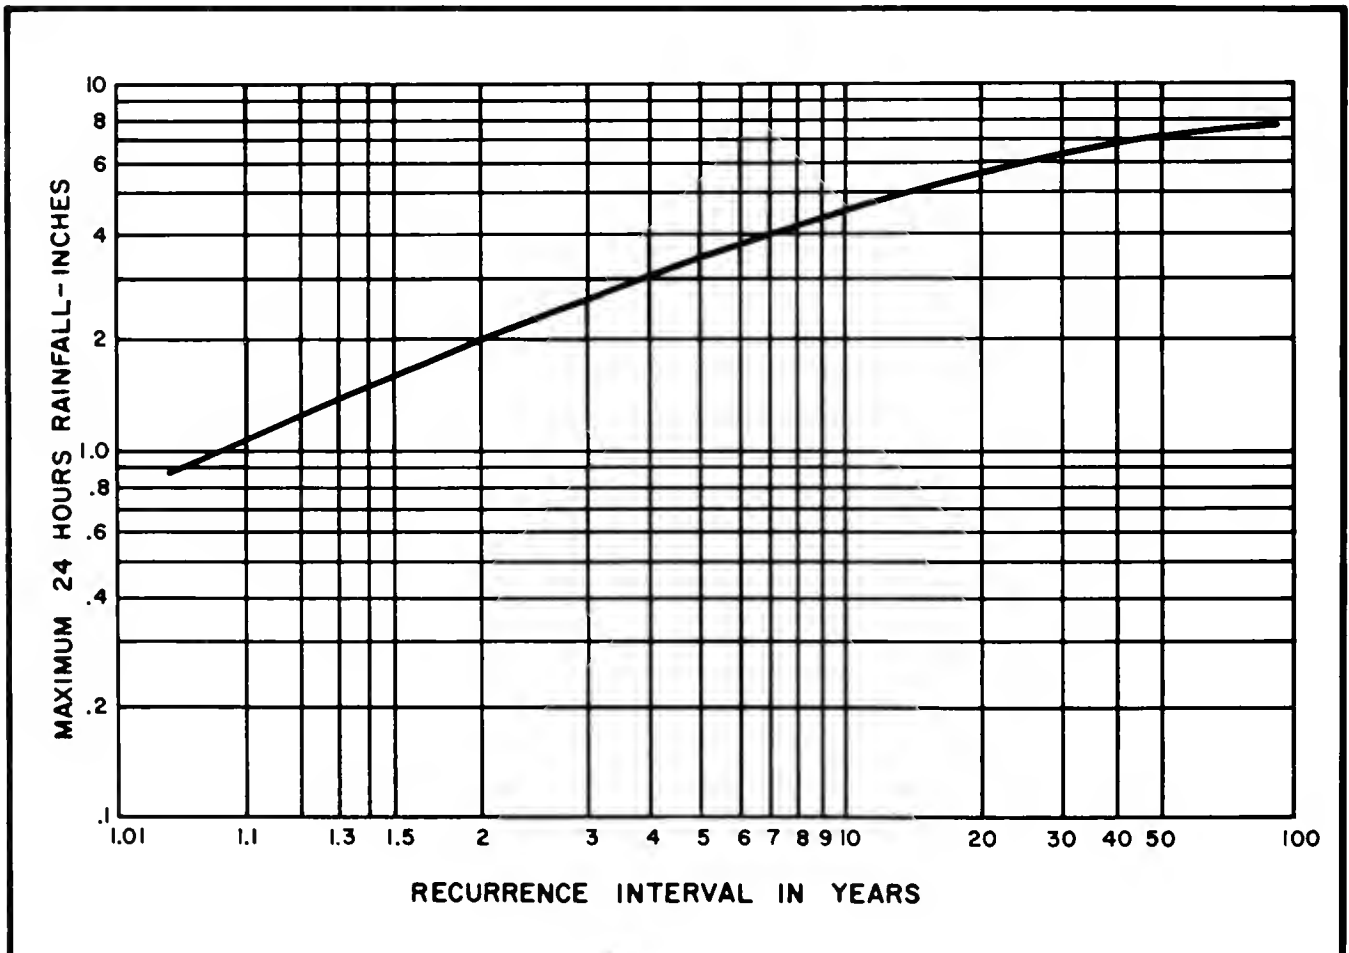
Figure 9 - 24-HOUR RAINFALL FREQUENCY CURVE  
AT WILDOMAR STATION (T7S, R4W, SEC.3)

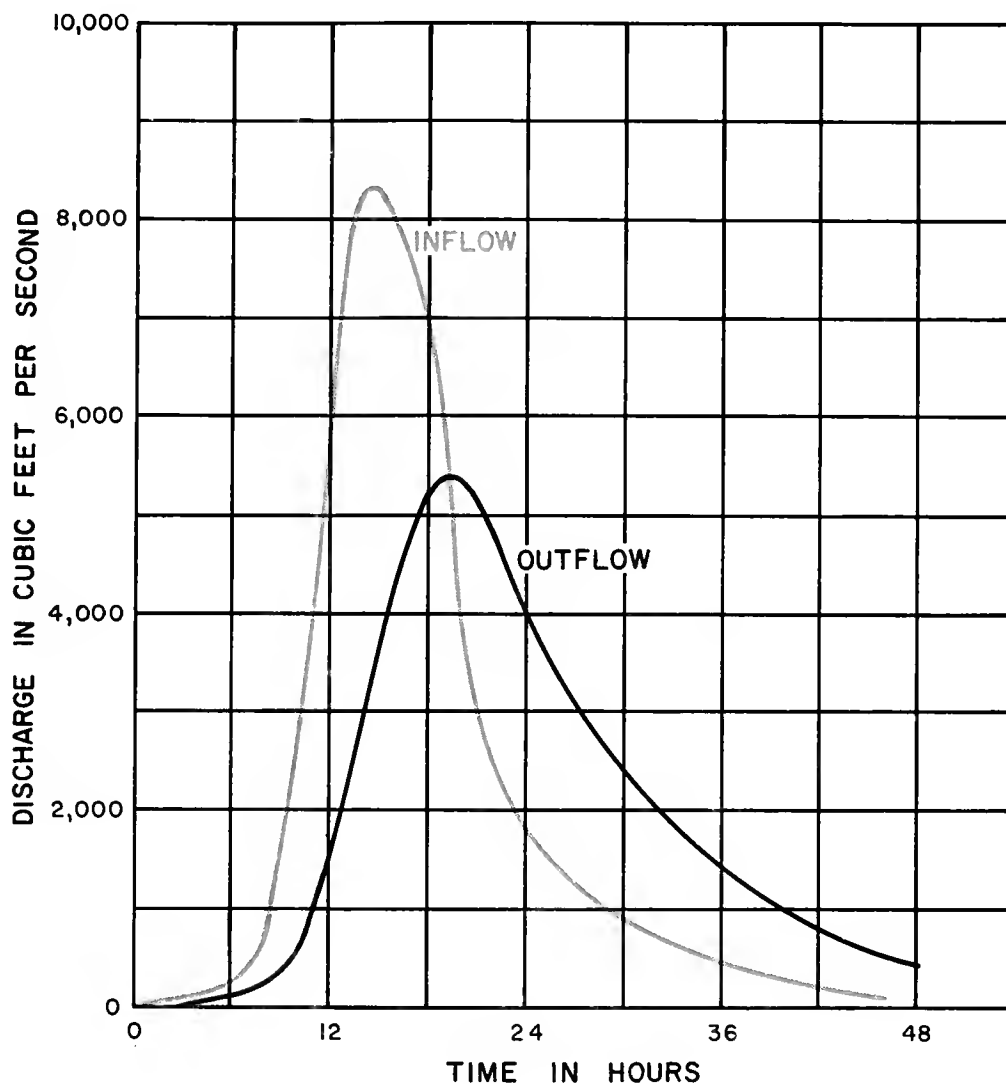
Figure 10—INFLOW-OUTFLOW HYDROGRAPH, LAKE SKINNER,  
100-YEAR-FREQUENCY FLOOD (FULL RESERVOIR)

Gertrudis Creek watershed. Although the reservoir does not have any available flood control storage, the outflow is less than the inflow as can be seen on Figure 10, because of surcharge storage above the spillway level.

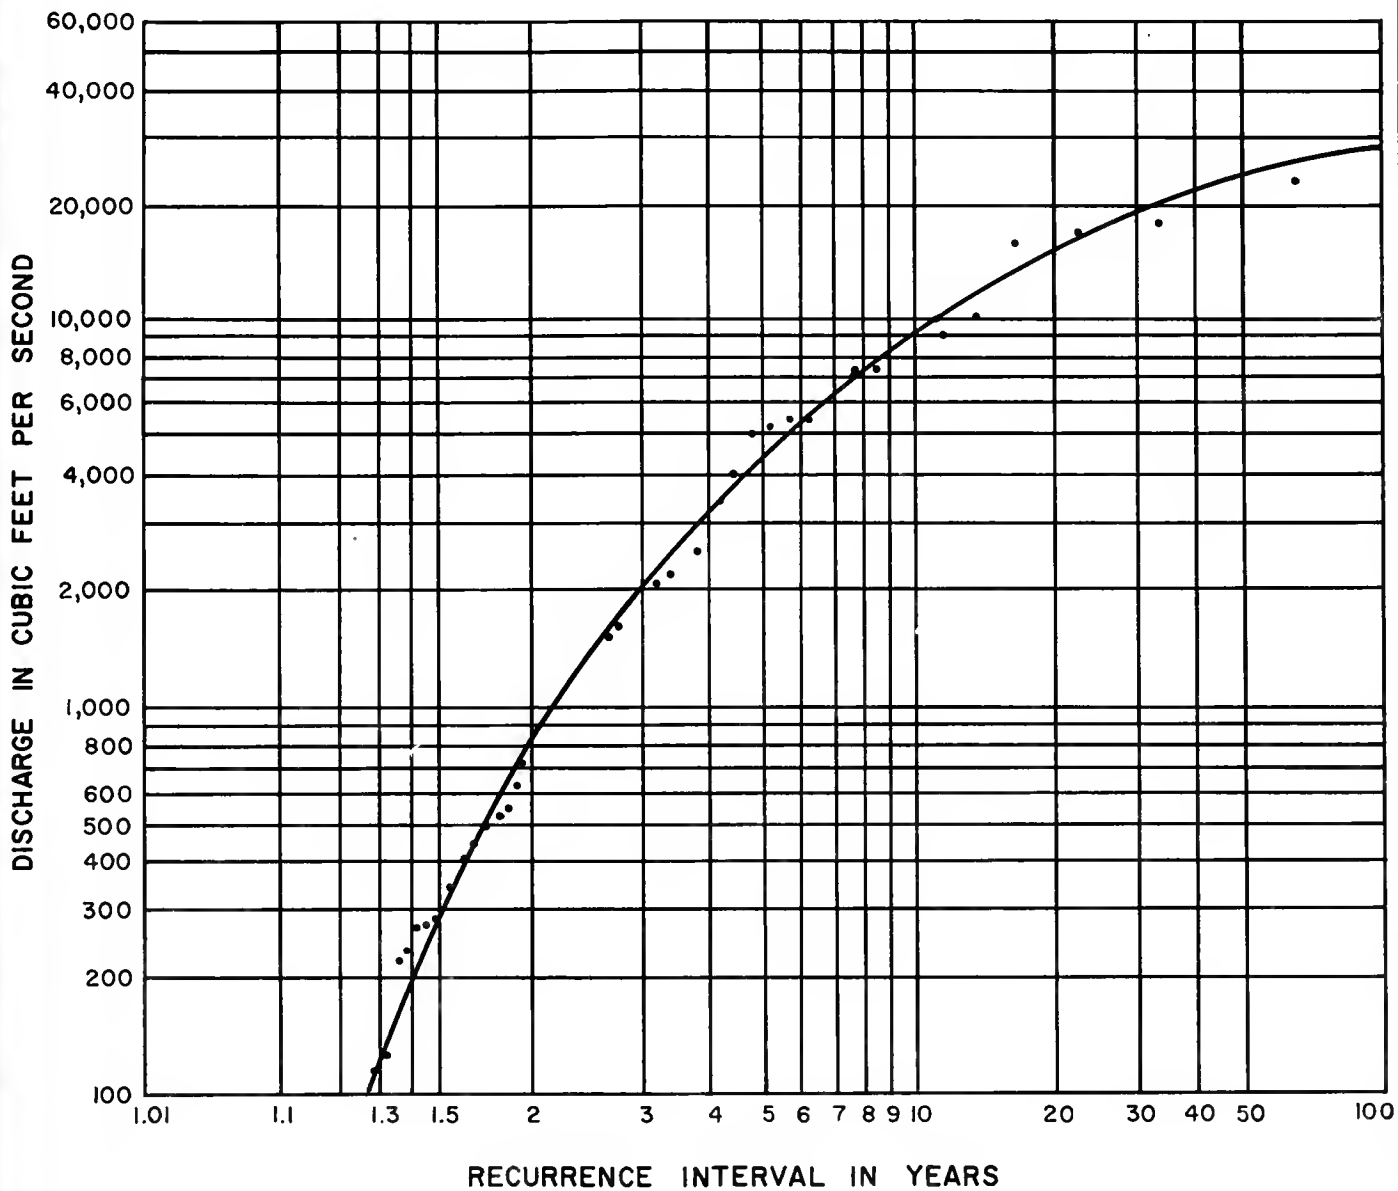
Figure II—DISCHARGE—FREQUENCY CURVE  
"MURRIETA CREEK AT TEMECULA"

In order to check the reasonableness of these peak discharges, a discharge frequency curve was developed for gaging station "Murrieta Creek at Temecula" from record (see Table 6). Plot of the curve is shown in Figure 11. Extrapolation of the curve shows a once-in-a-hundred year discharge of about 29,000 cfs which compares favorably with the 30,900 cfs computed for this study and with the District's unpublished study "Hydrology Report for Temecula and Murrieta Creeks and their Tributaries" and the U. S. Corps of Engineers' "Report on the Hydrology of the Santa Margarita River and Tributaries" of March 15 1949.

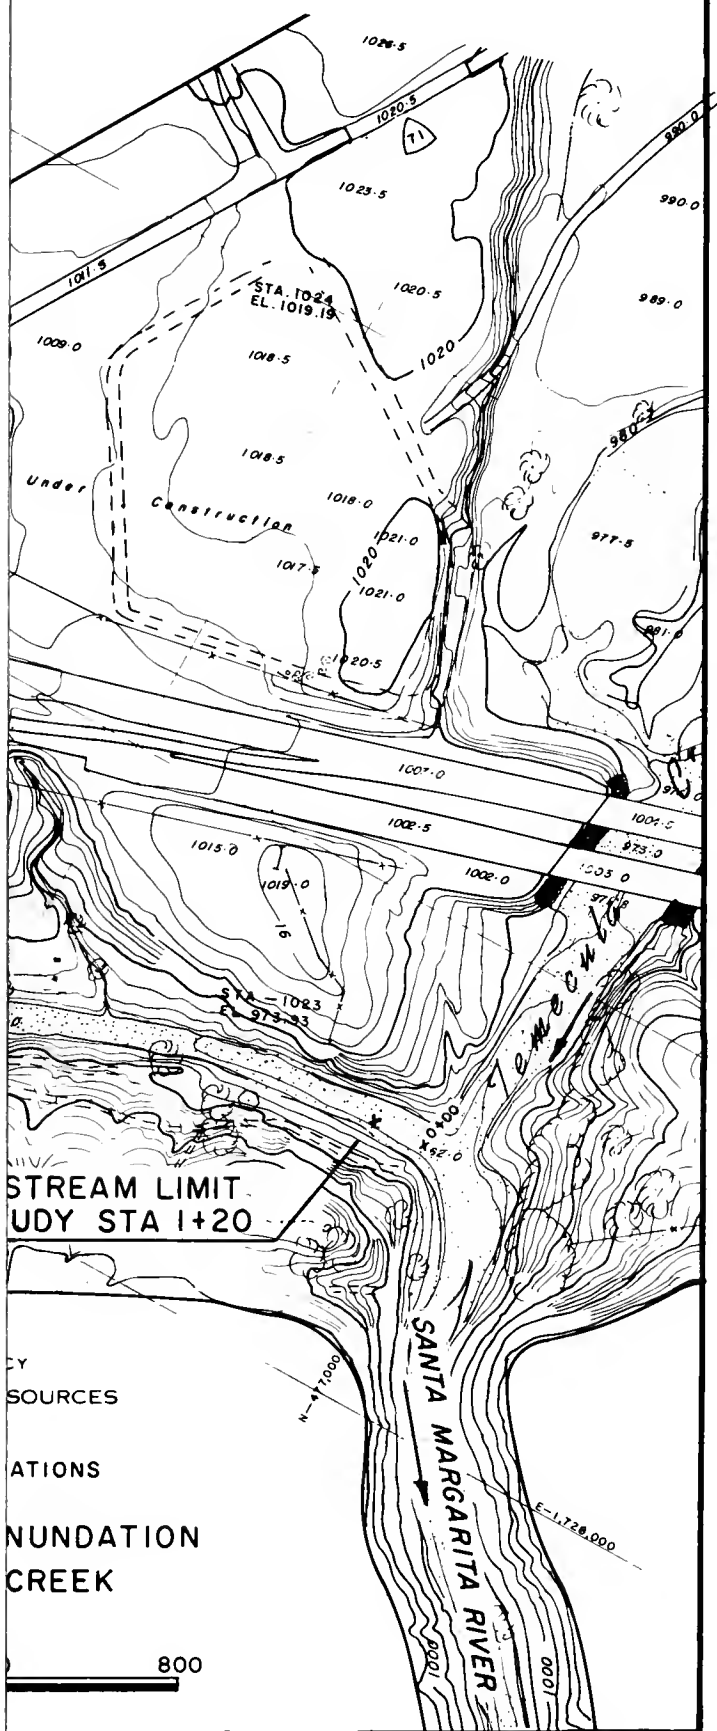
AREAS OF POTENTIAL INUNDATION  
REACH A MURRIETA CREEK

The computed water surface elevations were plotted on topographic maps furnished by the District, and the areas of potential inundation were delineated. Plates 1 through 10 show areas subject to flooding along Murrieta Creek and in the community of Temecula, as well as the industrial complex between Main Street and Rancho California Road. Many of the roads would be inundated wholly or in part with some overtopping of the bridge crossings at Main Street and Rancho California Road.

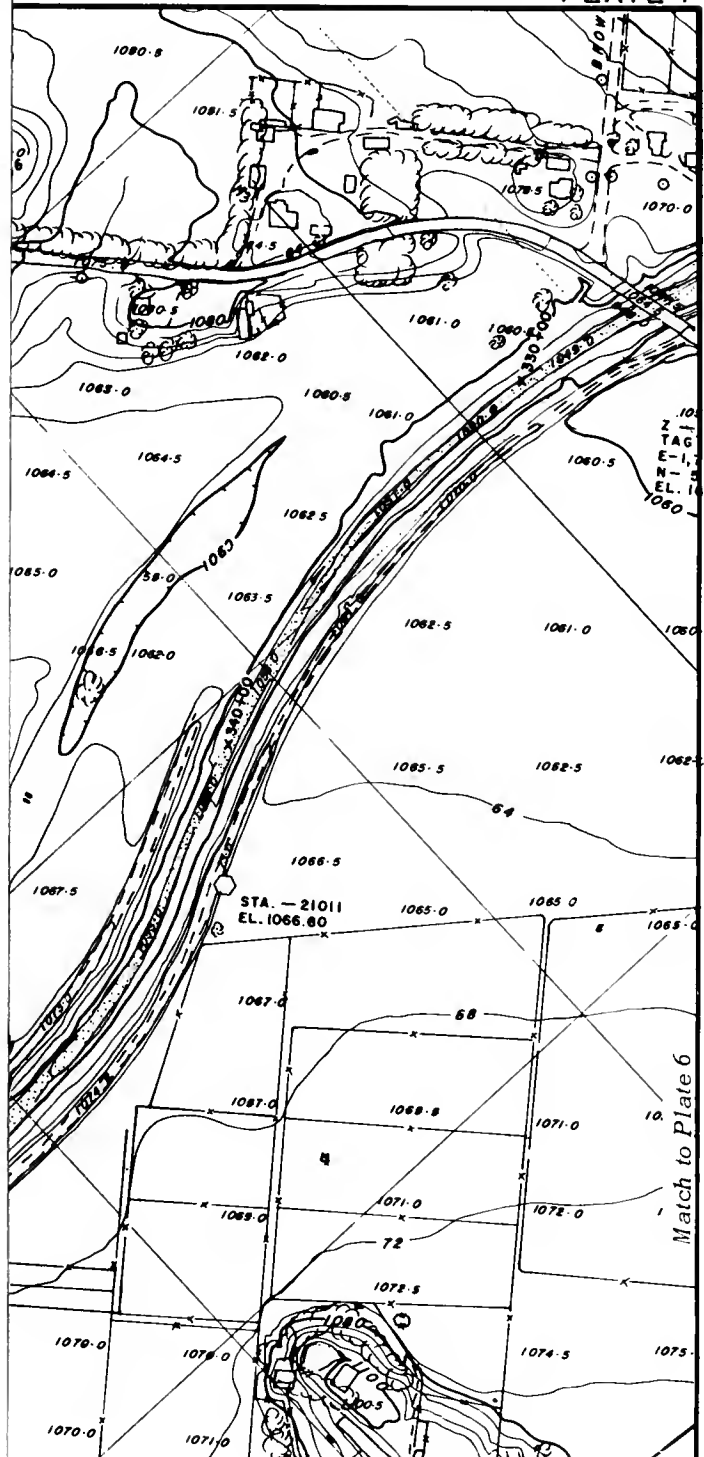
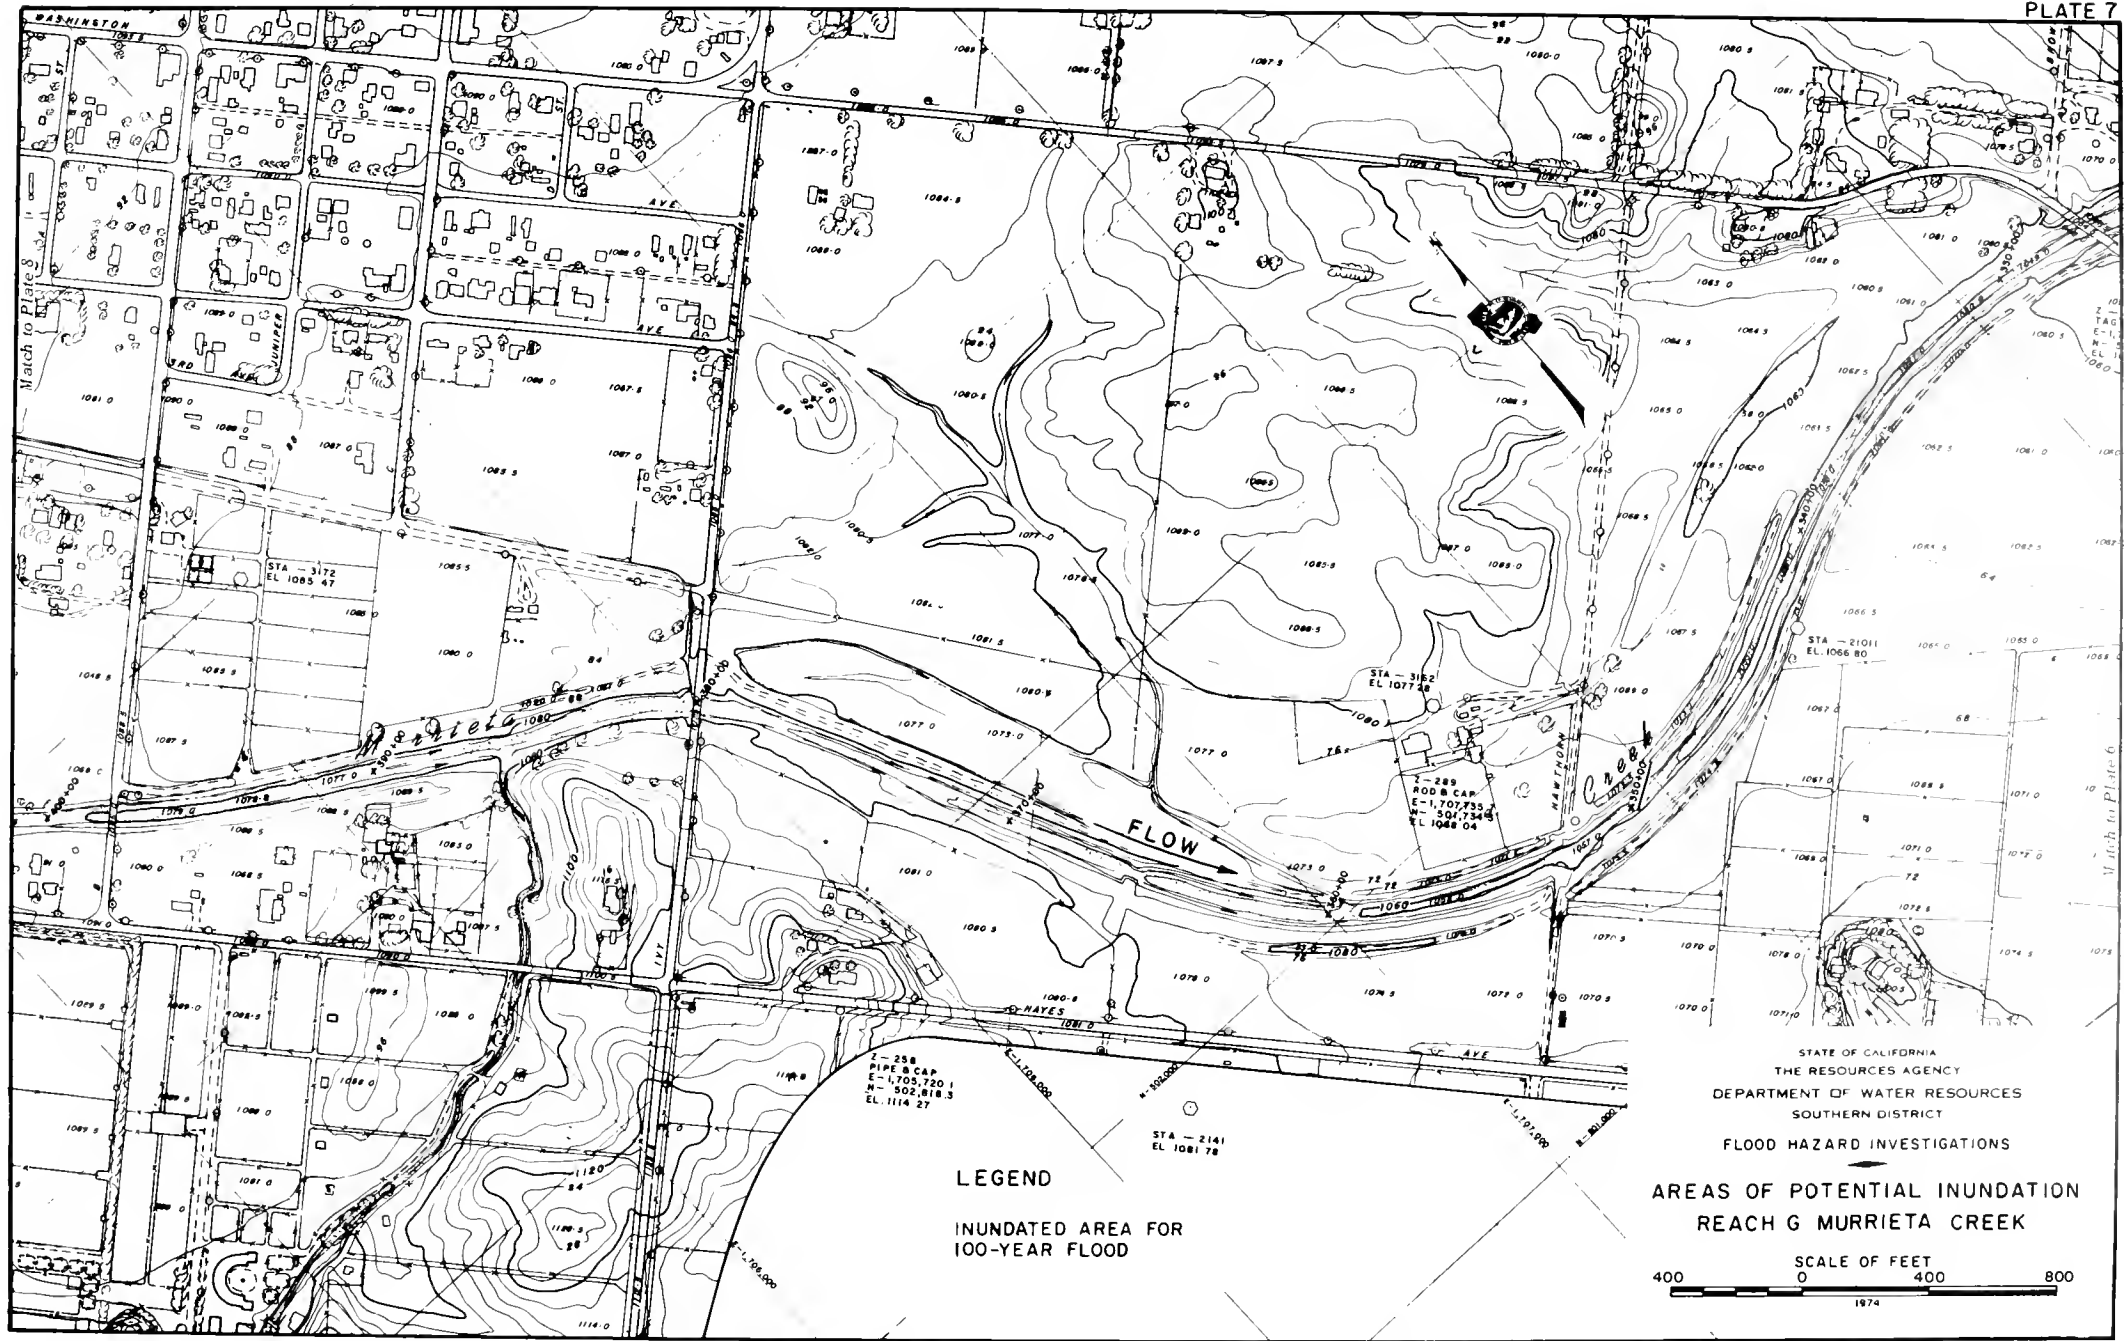
**AREAS OF POTENTIAL INUNDATION  
 REACH G MURRIETA CREEK**
